Monitoring the vertical and horizontal displacements of the Poiana Mărului dam

Stănescu Roxana Augustina¹, Nache Florin², Păunescu Cornel³

Abstract

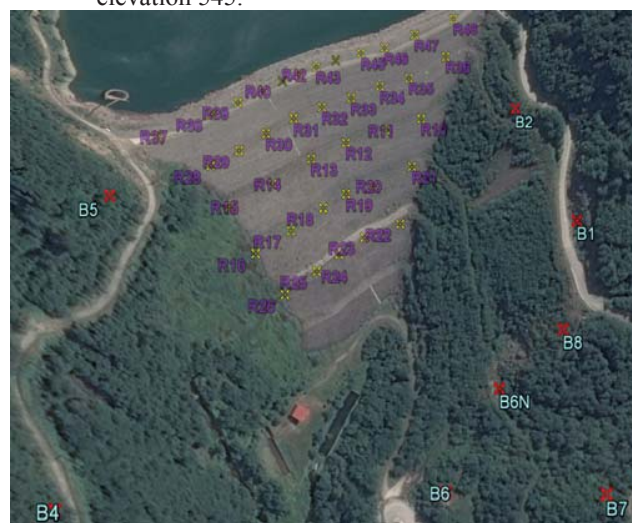
Fig. 3 Pilasters and monitoring markers

The microtriangulation network consists of six pilasters B1, B6N, B7 and B8 left bank; two pilasters B4, B5 - right bank and 39 monitoring marks (Fig. 3).

The access to the pilasters and berm marks was properly done, except for pillars B1, B6N and B7. At these pilasters the access was difficult because of the absence of the road, the access to them could only be made through the swamp or on steep slopes.

- verification of the access to the pilasters, of the fundamental bench marks and monitoring marks;
- deforestation of vegetation that obstructs the sights;
- verification of the forced centering systems;
- verification of the integrity of the pilasters, monitoring bench marks, fundamental and monitoring marks.

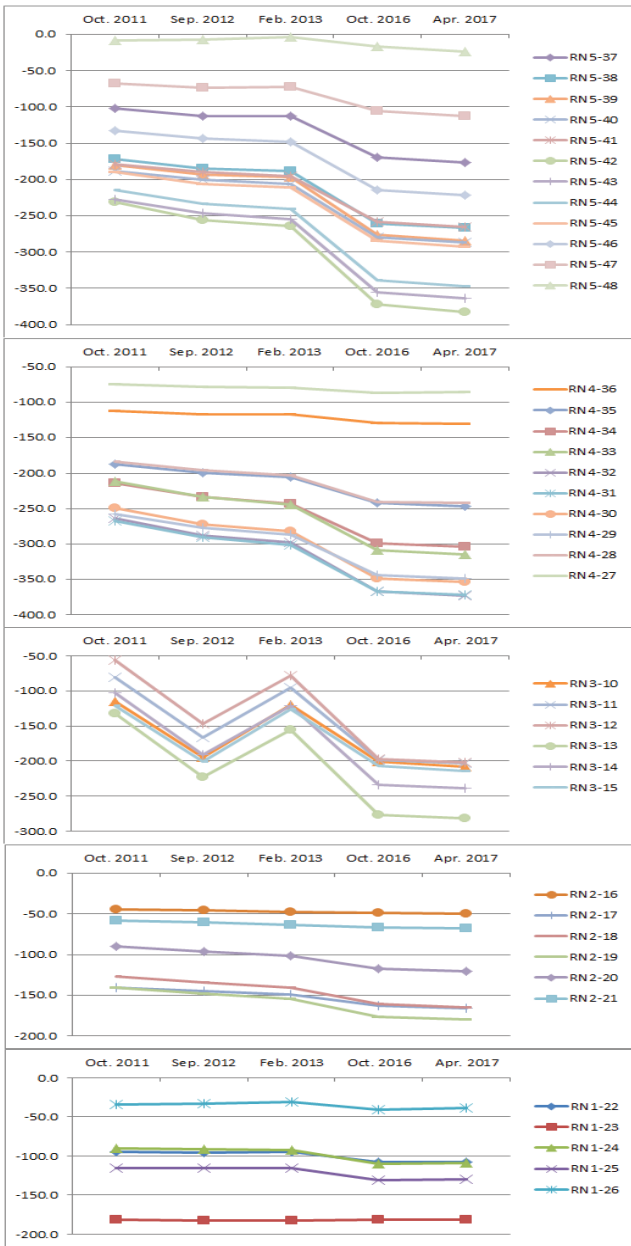
Fig. 4 Vertical displacements in relation to period 0 of the last 5 measurement periods

The vertical displacements of the last 5 periods are represented graphically (Fig. 4).

The maximum displacements determined within the altimetric monitoring network between the two measurement periods are illustrated below:

- 1.8 mm (swelling) for bench mark RN1-26 (berm 545)
- 3.9 mm (settling) for bench mark RN2-19 (berm 565)
- 7.0 mm (settling) for bench mark RN3-15 (berm 585)
- 5.6 mm (settling) for the bench mark RN4-32 (berm 605)
- 10.0 mm (settling) for the bench mark RN5-42 (crowning)
